Technical Report ARFSD-TR-03002

PREDICTING THE CAUSE OF FAILURE IN 120-mm MORTAR FINs

July 2003

U.S. ARMY ARMAMENT RESEARCH, DEVELOPMENT AND
ENGINEERING CENTER

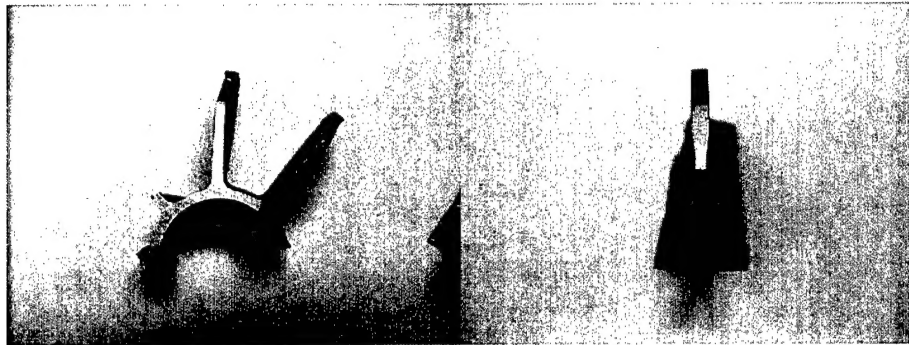
Figure 2
Two broken fin parts, flat fin plus cylindrical part

cause of failure between fins (fig. 2) is a defect at a high-hoop stress region that results in fracture failure. The fracture failure occurs from an internal pressure in the fin cylinder. Yielding is probably not visible.

crack size was estimated at 0.23 mm (0.009 in.). As shown in figure 2, several of the broken fins had failure modes consistent with fracture failure. The failure surface was rough and without discernable yielding of the fins or fin cylinder.

The analysis indicated that a fracture could occur with large internal pressures at critical defects. The smallest crack size was predicted with longitudinal cracks on the inside of the fin cylinder. This type of defect is consistent with scoring due to assembly at the press fit. Evidence of scoring was found in some broken parts, but it was not clear that scoring had caused a specific failure. However, the broken parts shown in figure 2 are consistent with the high stress regions in figure 6b.

Six-sigma techniques are being used to assess the manufacturing and assembly process. The goal is to reduce the size and number of scoring defects on the inside of the fin cylinder.

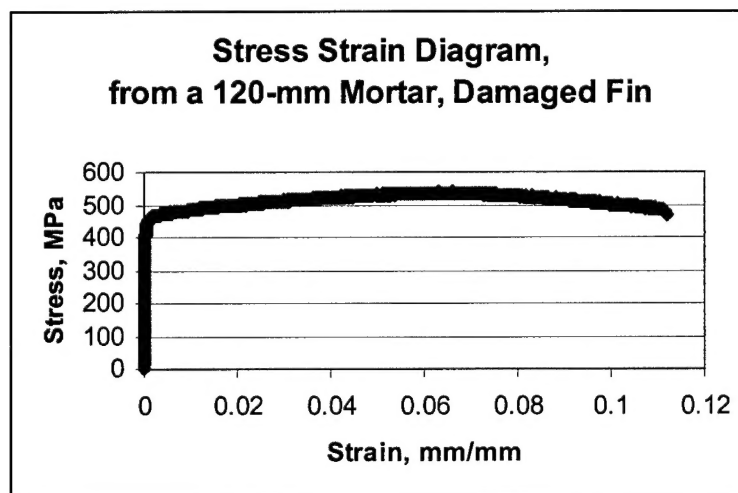
Both parts of the tail assembly were extruded from aluminum. Young's Modulus was 73,023 MPa, Poisson's ratio was 0.3, and the mass density was 2.3-gm/cm³. The perforated section was modeled as a linear-elastic material. The fin section was modeled as an elastic-plastic material. Points from a tensile test of a fin were used to model the fin part (fig. 5). The engineering yield and ultimate strength were 464 and 502 MPa. ABAQUS uses the true stress and strain, 466 MPa for yield and 538 MPa for ultimate tensile strength.

Figure 5
Stress/strain diagram from damaged fin

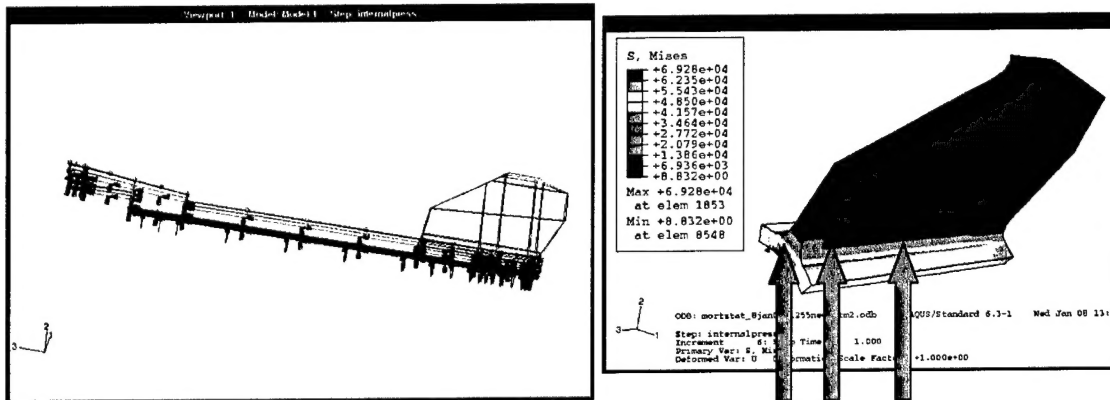
The internal pressure of 98 MPa, load case 2 from table 1, resulted in three, high-stress regions (fig. 6b). There are high von Mises stresses directly under the fin and at the inner diameter of the cylinder, at the fin fillet on the outside of the fin cylinder, and midway between the fins on the inside of the fin tube. Yielding was predicted directly under the fin on the inside of the cylinder. The plastic region did not go through the thickness of the cylinder and the von Mises stress was below the ultimate tensile strength of the aluminum.

Figure 6
Internal pressure on fin assembly, 98 MPa

Critical crack sizes were predicted for the three high-stress regions shown in figure 6b. The smallest critical cracks resulted from the longitudinal cracks opened by the hoop stresses. For load, the 98-MPa internal pressure, the smallest critical flaw on the inside of the cylinder, was estimated at 0.18 mm (0.007 in.). Along the outside of the cylinder, the smallest critical

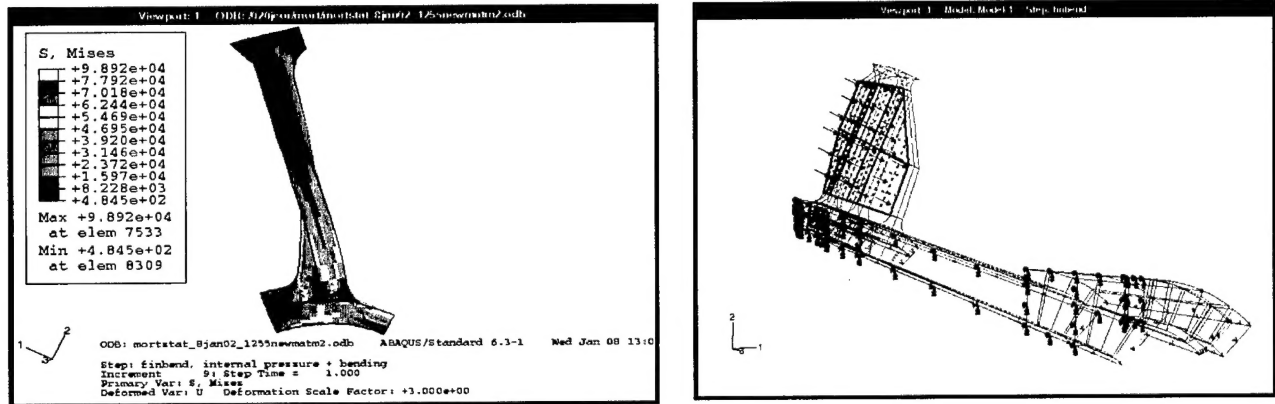
Figure 7a shows load case 4, an unequal pressure on one side of the fin. A pressure of 1.4 MPa resulted in yielding of the fin near the root. A pressure of 2.1 MPa resulted in von Mises stresses exceeding the ultimate tensile strength of the aluminum (figure 7b in units psi). At the 2.1-MPa pressure, the plastic zone extended through the fin thickness, indicating probable tearing of the fin at this location. Numerous examples of broken and twisted fins were consistent with the deformation and stresses shown in figure 7b.

Figure 7
Load case 4: pressure on one side of fin

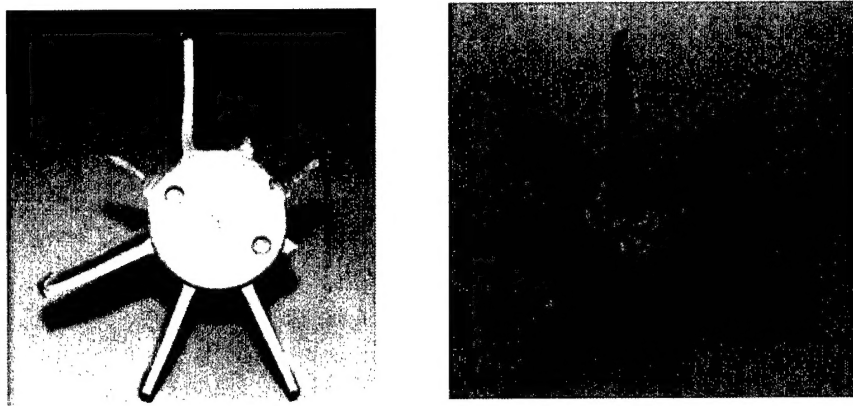
Additional evidence of unequal pressure as a proximal cause of failure occurred in recent short-rounds. In the broken short-rounds in figure 8, two adjacent damaged fins appear to be twisting away from the same spot, indicating high pressure between two fins. In figure 8a, note the fins at 10:00 and 12:00 seem to be twisting in opposite directions. Similarly the damaged fins in figure 8b seem to be twisting away from one another. Note the fins at 4:00 and 6:00 in figure 8b.

Figure 8
Evidence of high unequal pressure between two fins
